PUBLIC ROADS

A JOURNAL OF HIGHWAY RESEARCH

A BITUMINOUS CONCRETE ROAD ON ITS TWENTIETH BIRTHDAY

Page
Static Load and Impact Tests of Lightweight Bridge Floor Slabs	105
Bituminous Concrete on Connecticut Avenue Experimental Road	120

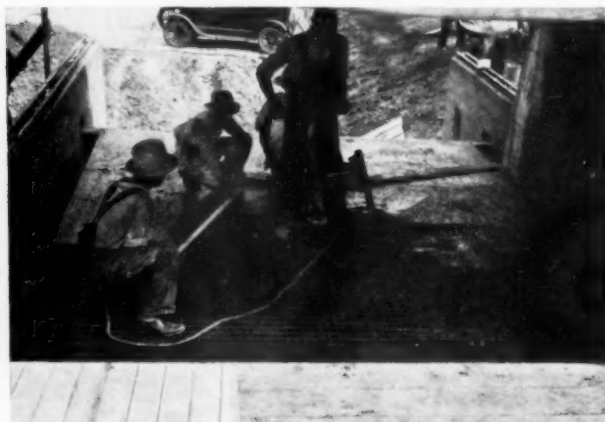
FIGURE 3.—COMPLETED STEEL MAT OF FIRST SLAB BEING FILLED WITH CONCRETE BY MEANS OF ELECTRIC VIBRATOR

The concrete was mixed in a power-driven mixer for two minutes, wheeled to the slab and vibrated into place with an electrically operated vibrator, as shown in Figure 3. After the concrete had been vibrated into place the surface was struck off with a wooden screed and roughly floated with a wooden float. It was then covered with wet burlap until the next morning, when the burlap was

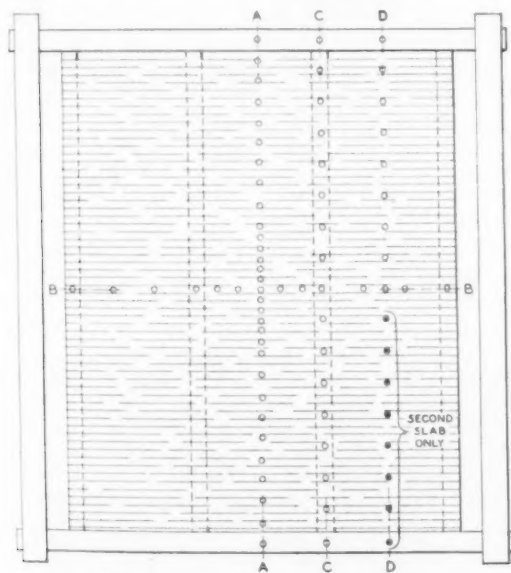
FIGURE 7.—PLAN OF SLAB SHOWING DEFLECTION POINTS

For all of the above loadings the deflections of both the slab and I-beams were determined and strains were measured both in the T-bars and in the two center stringers at the points shown on Figures 7 and 8.

All of the deflection measurements were made with two movable staffs of different length, one being used under the stringers and the other under the T-bars of the slab proper. These staffs were moved from point to point after the desired load was on the slab. The deflection of the floor beams was measured by similar staffs which, however, were left in position and not moved from point to point. The positions of all deflection points are shown in Figure 7.

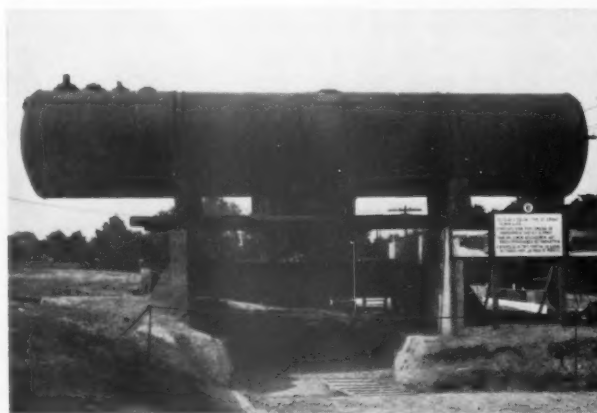
FIGURE 9.—GENERAL ARRANGEMENT OF TEST SLAB, SUPPORTING WALLS, AND TANK USED FOR THE APPLICATION OF THE STATIC LOADS
